Images in Structural Heart Disease

Superior Mesenteric Artery Embolism Complicating Transcatheter Aortic Valve Replacement

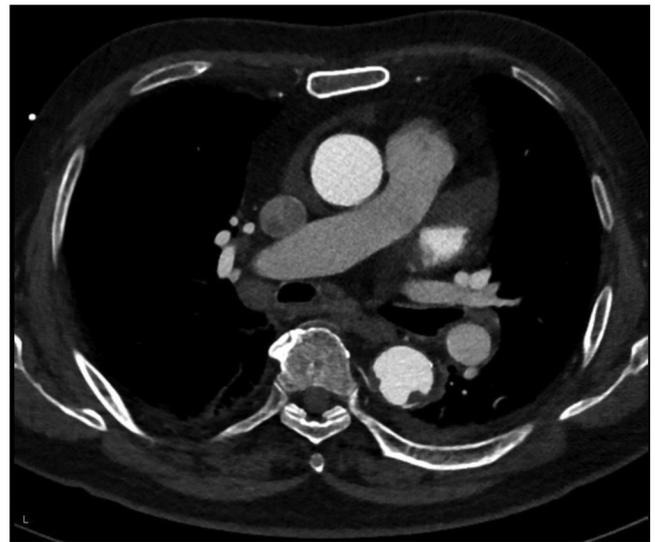
Figure 1. Preprocedural computed tomography showing protruding plaques into the descending aortic lumen.

An 83-year-old male was scheduled for transcatheter aortic valve replacement for severe aortic valve stenosis. Although preprocedural computed tomography demonstrated atherosclerotic plaques protruding into the descending aortic lumen (Figure 1), we concluded a transfemoral approach was feasible. However, while advancing the valve system through the descending aorta, the echocardiographer detected a fragment detached from the protruding plaque on transesophageal echocardiography (not recorded). A 26-mm Sapien 3 (Edwards Lifesciences, Irvine, California) was successfully implanted (Figure 2) while transesophageal echocardiography delineated a contrasting configuration of the plaque (Figure 3a and b, Supplemental Video 1). Emergency superior mesenteric artery angiography demonstrated an embolic partial obstruction (Figure 4a), and an

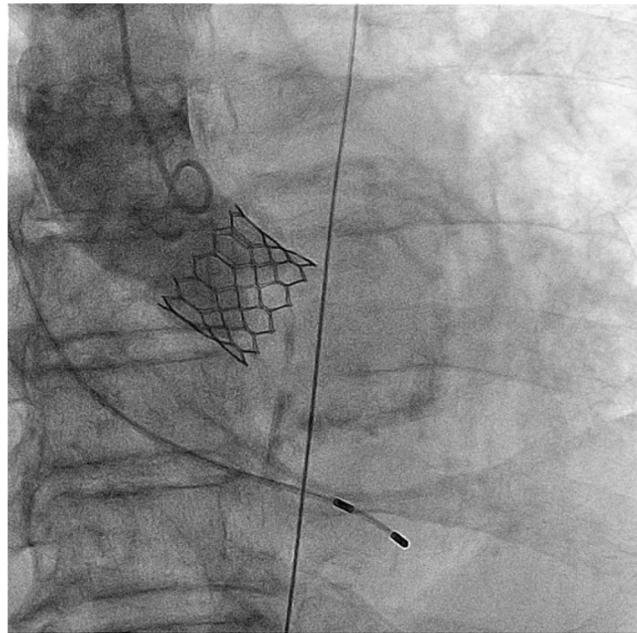
Figure 2. Aortography after Sapien 3 implantation.

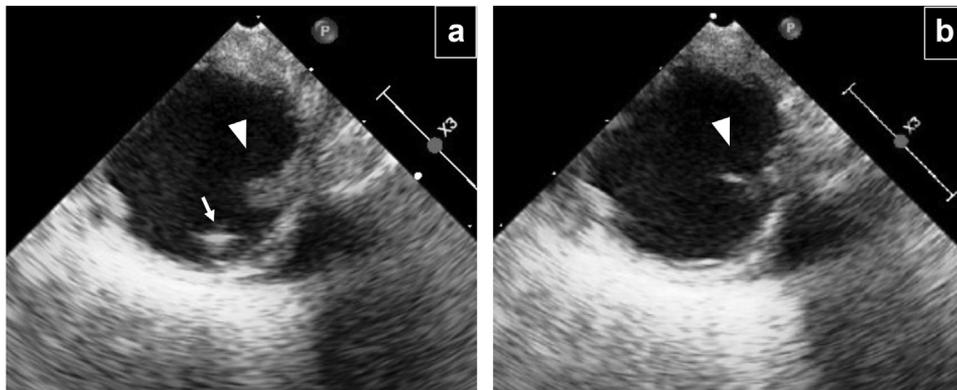
Figure 3. Transesophageal echocardiography (TEE) showing a guidewire (arrow) with the protruding plaque (arrowhead) before (a) and after (b) device advancement.

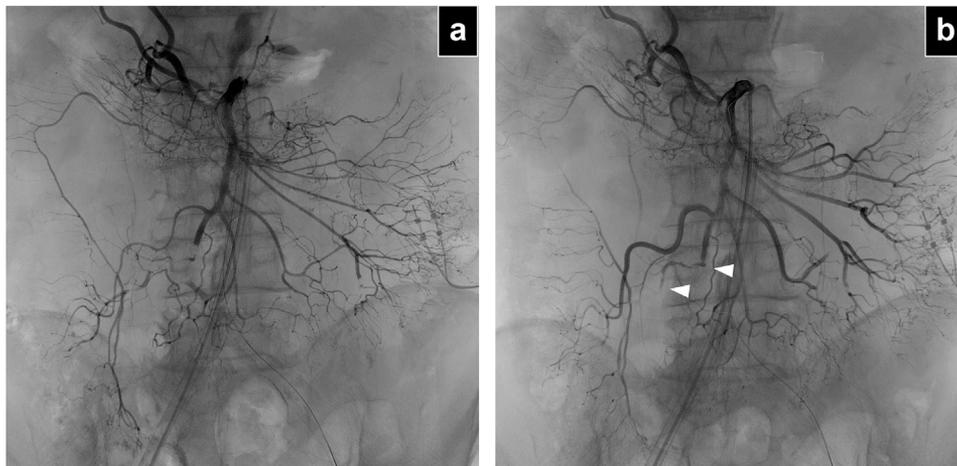
Figure 4. Superior mesenteric artery angiography showing embolic partial obstruction of the mid portion before the aspiration procedure (a) and restoration of blood flow to ileocolic territory after the procedure (b). Arrow heads indicate partially improved blood flow to iliocolic territory.

intravascular aspiration procedure, using an Export Advance catheter (Medtronic, Minneapolis, Minnesota), restored blood flow to the ileocolic territory (Figure 4b). His post-transcatheter aortic valve replacement course

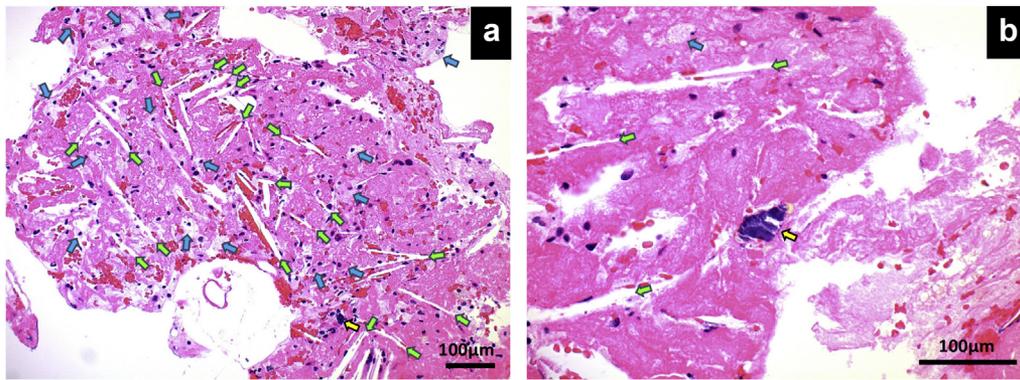
Figure 5. Pathology of the aspirate showing cholesterol clefts (green arrows), foamy macrophages (blue arrows), and calcification (yellow arrow) in low (a) and high (b) magnifications.

was uneventful with no signs of bowel ischemia. Pathology showed the retrieved material was a fragment of atherosclerotic plaque with typical cholesterol clefts and foamy macrophages (Figure 5a and b).
